Summary Report DOE/EM-0507

# Non-Intrusive Liquid Level Detection System

Deactivation and Decommissioning  
Focus Area

*Demonstrated at*  
Hanford Site  
Richland, Washington

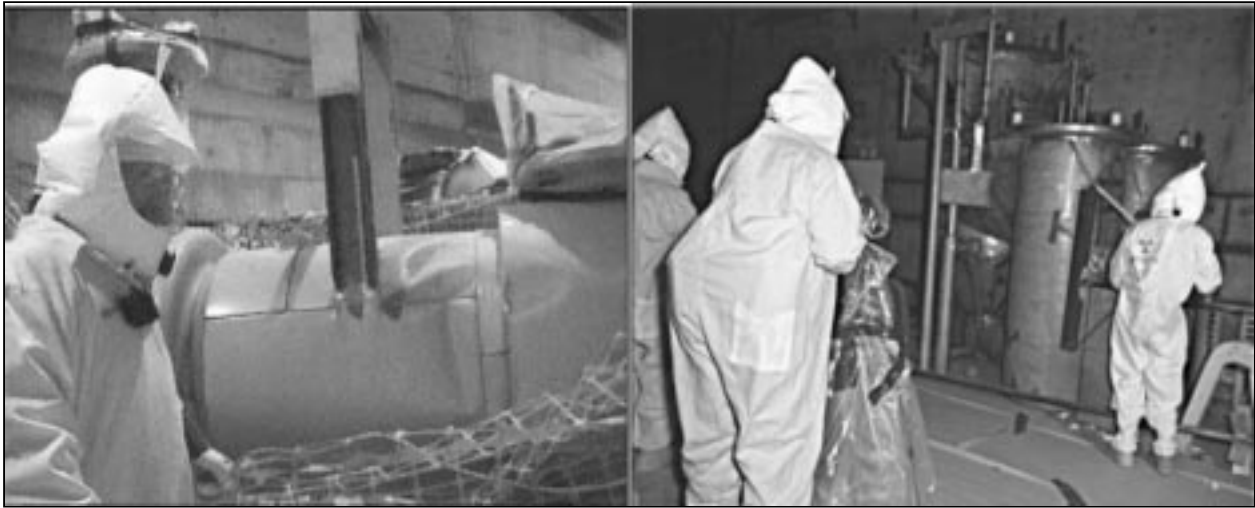
**Figure 3 NLLDT Equipment Survey in 221-U Facility**

The demonstration survey conducted in the 221-U Facility was performed with three people. Figure 3 at the top of the next page shows the number and activities of the crew during the demonstration. The number of personnel can be reduced to two in routine surveys. In this three-person operation two separate Infrared Imaging Cameras were utilized. The third technician captured visual images of the

targets and provided other support functions as required. In a two-person crew, there will be one Thermographer and a technician. The technician will assist the thermographer and apply the external heating if it is required.

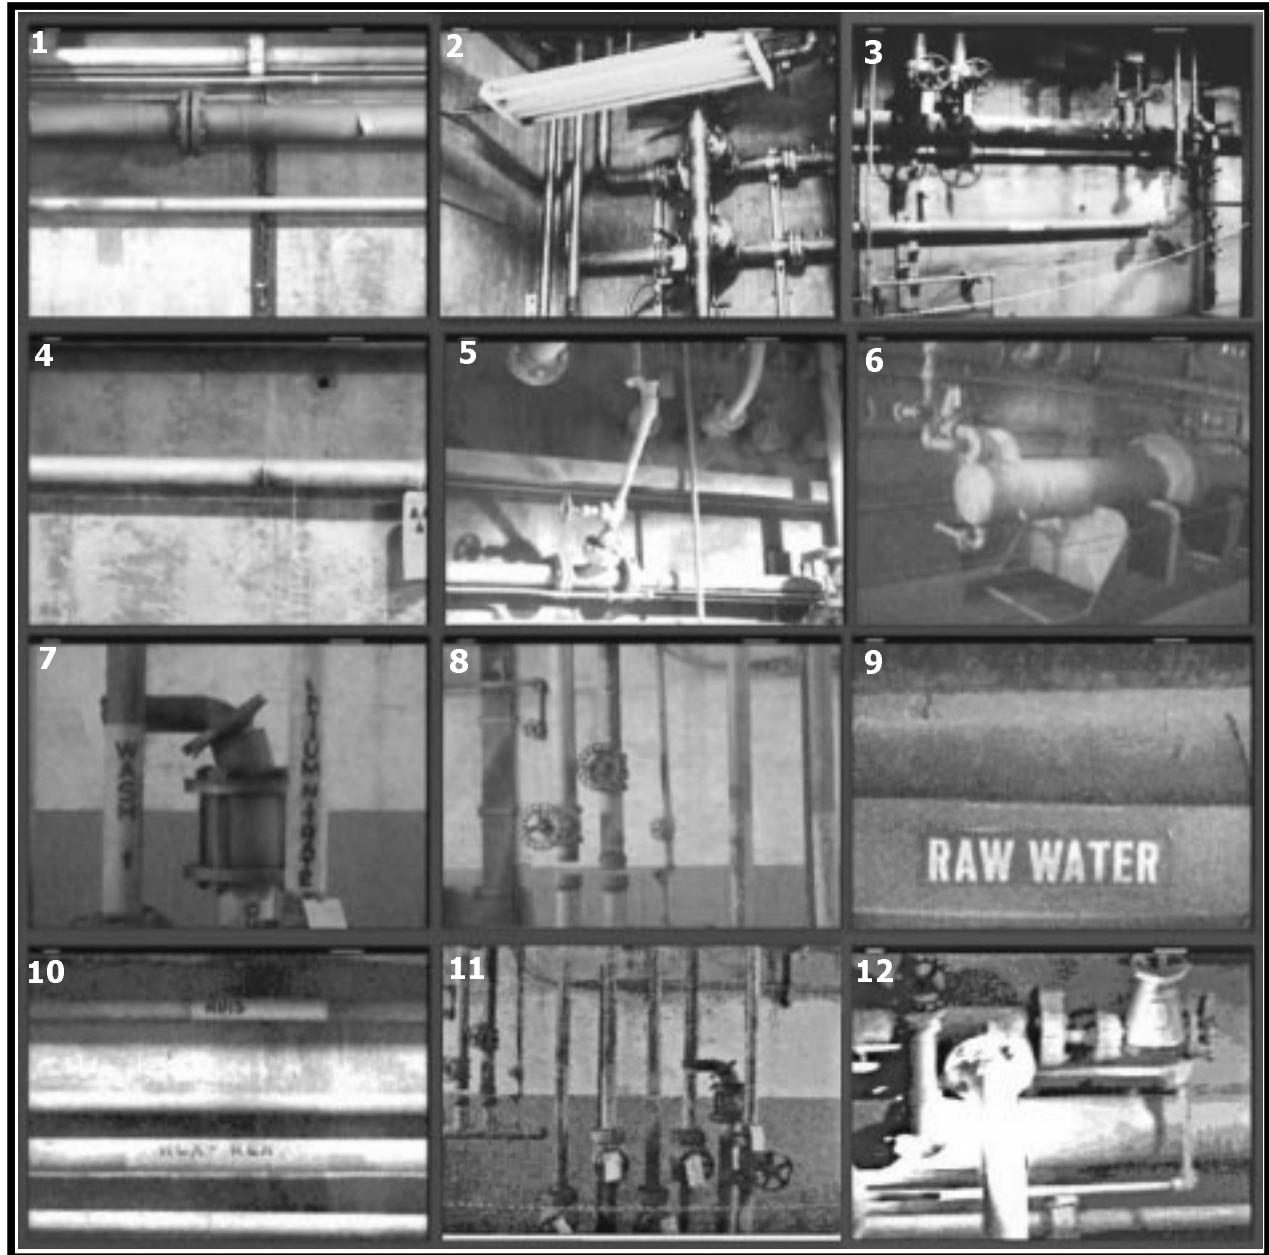
Following are visual images of the piping assemblies located in the 221-U Facility.

| 3. Pipe Arrangement, 30' East Door 17 | 12. Pipe Elbow, 50' West Door 13, NaOH Leak. |
